June 14, 2018
Project No. C522-001

Re: Geotechnical and Geologic Review
Existing Commercial Building Site
1091 Esplanade Avenue
San Jacinto, California

INTRODUCTION

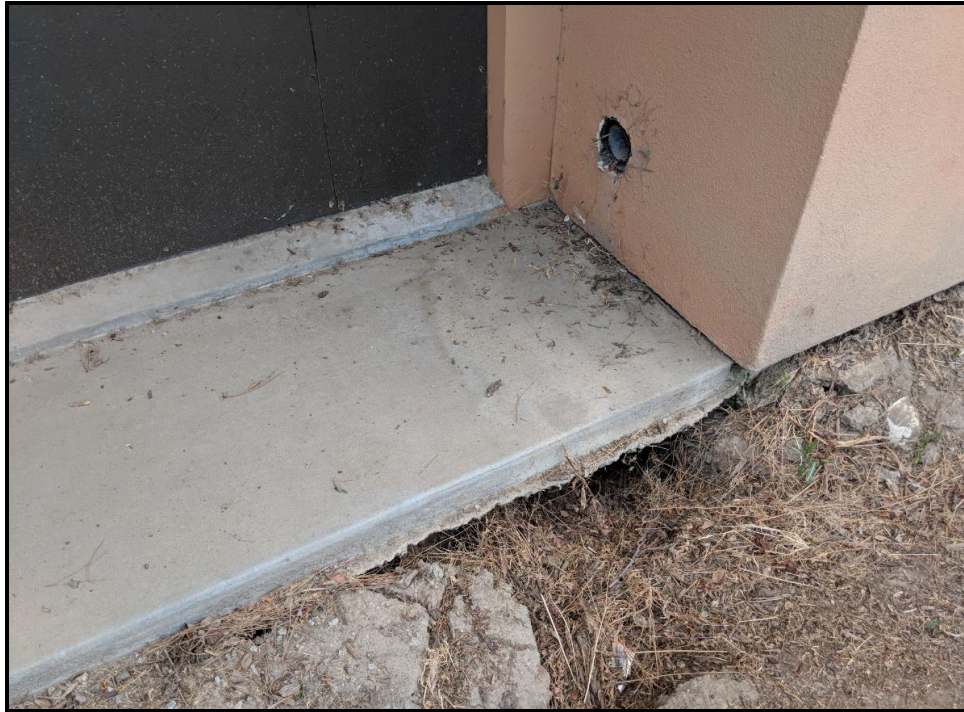
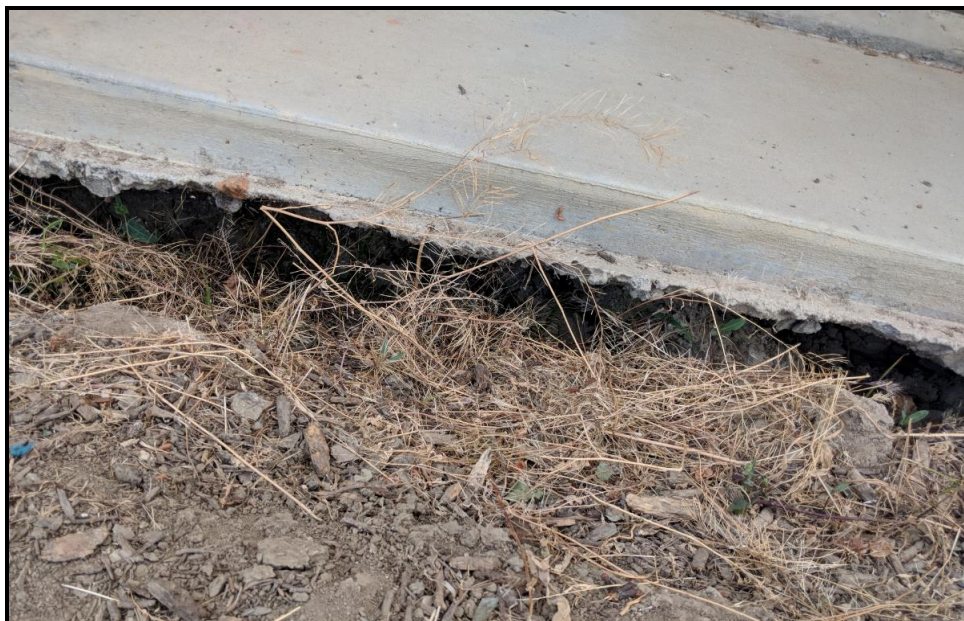
vandalism damage noted above). Rectangular concrete patch areas were observed on the ground floor slab, possibly related to sewer piping. Erosional undermining of the slab was observed at several locations along the northerly exterior wall. This erosion appears to have been caused by a leaking water or sprinkler pipe. The extent of undermining is not known at this time. Following are photos showing the erosion and undermining.

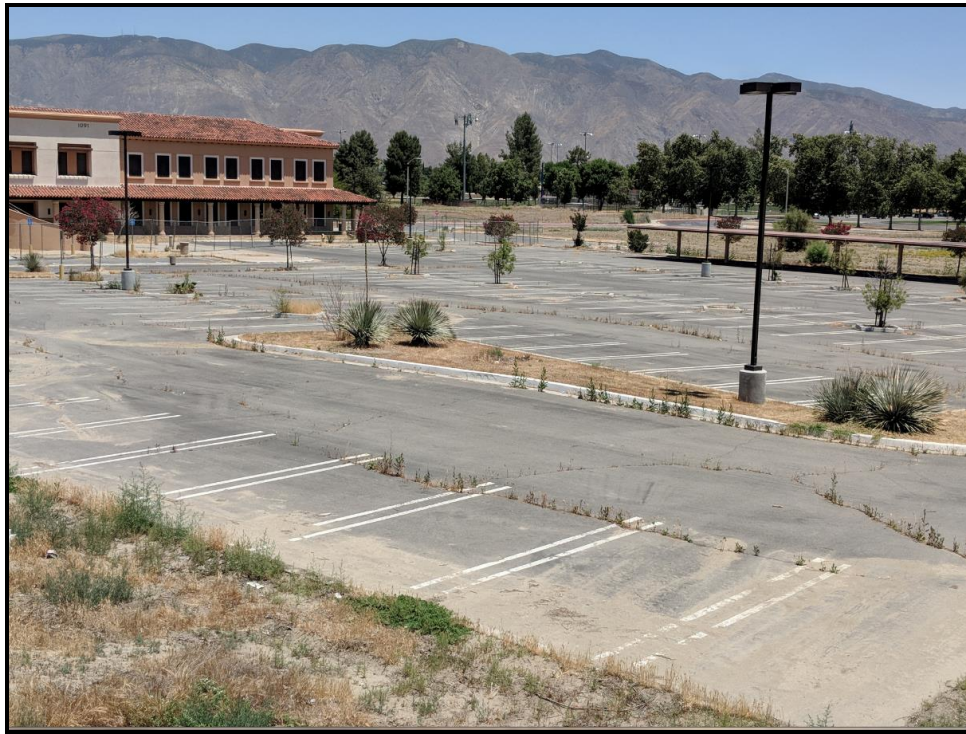
The asphalt concrete parking lot located to the south of the structure has deteriorated since being constructed in 2008. Apparent shrinkage cracking was observed across most of the

parking lot with weeds growing in the cracks. Following is a photograph of the parking lot area in its current state.
